STATE OF WASHINGTON
DEPARTMENT OF ECOLOGY
7272 Cleanwater Lane, LU-11 • Olympia, Washington 98504 • (206) 753-2353

MEMORANDUM
May 19, 1982

Subject: Purdy Shopping Center Sanitary System/storm Drain Fecal Coliform and Rhodamine WT Dye Study

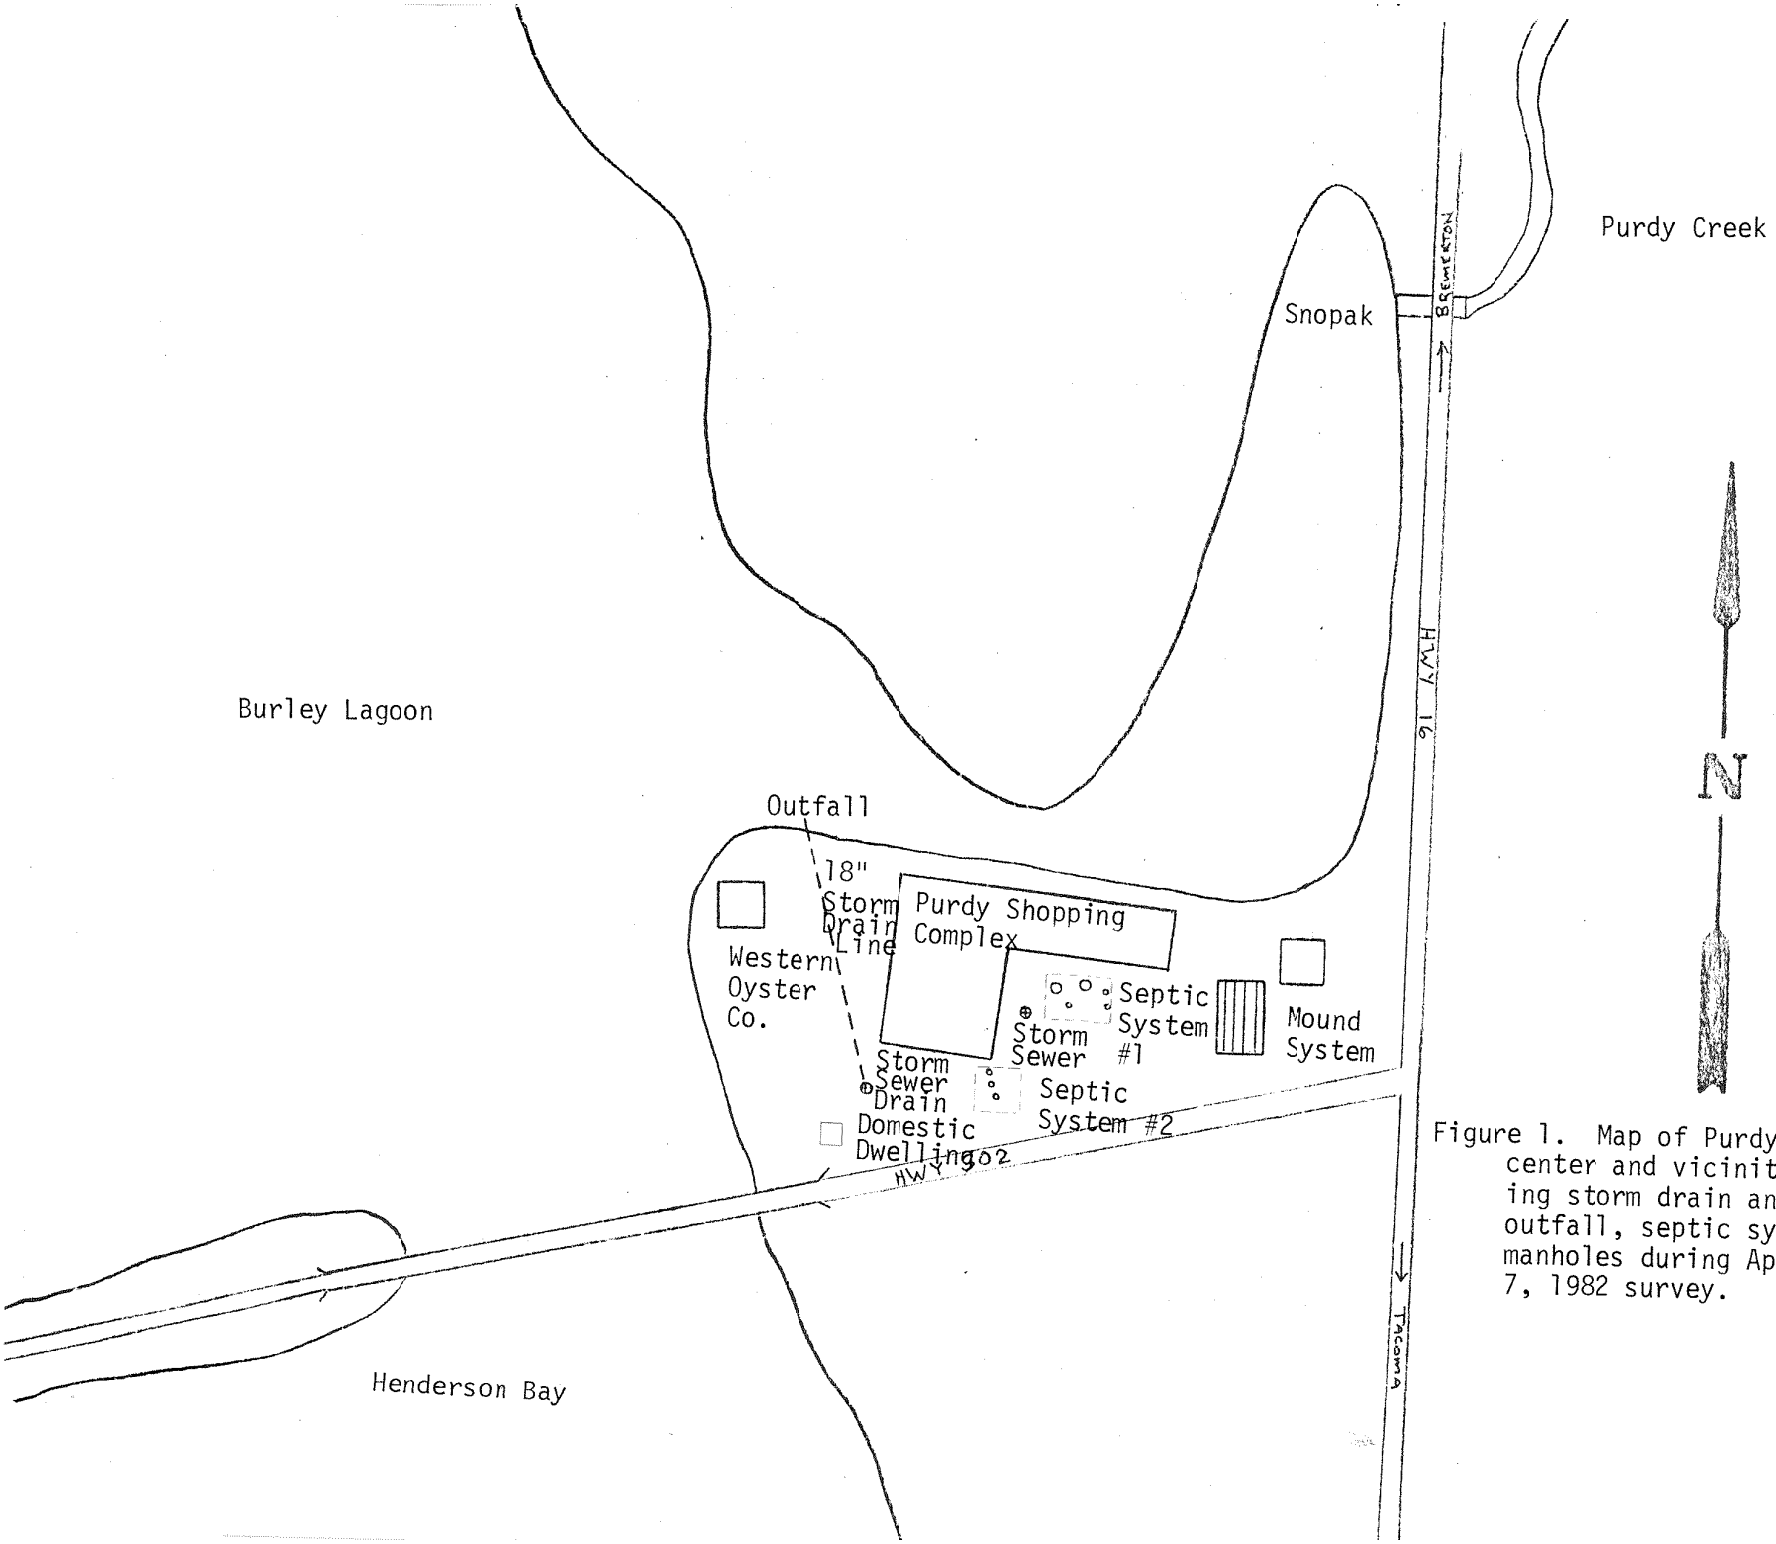
On April 6, 1982 during a visual survey of septic systems #1 and #2, it was apparent that system #2 displayed signs of possible drainfield failure. Upon removal of three six-inch manhole covers, it was evident that material in the system had risen to the top of the ports at some recent time. Upon request, the employees of the grocery store turned on several taps and flushed a connecting toilet which resulted in water in two of the manholes rising to within two inches of the cover.

Due to the proximity of system #2 to the storm drain (Figure 1), it was decided to test the system the following day using Rhodamine WT dye.

No rain fell during sampling, therefore only water from the septic system that could travel the 20 feet over dry roadway to the storm drain collector ever entered the receiving water. During a period of rainfall, overflow episodes could result in a higher percentage of sewage contact since the storm water would carry the effluent along with it. The effluent follows the parking lot slope directly to the storm drain.

Leaching from the septic system drainfield #2 into the surrounding landfill does not appear to be a significant pathway for fecal contamination of the storm sewer. Background levels remained at close to or less than 1 fecal coliform per 100 ml prior to and following the overflow event. The overflow suggests that the drainfield lacks sufficient carrying capacity for the septic tank as documented by the overflow and past high fecal coliform counts collected at the storm sewer outfall (Cox, 1981).

Figure 1. Map of Purdy shopping center and vicinity displaying storm drain and associated outfall, septic systems, and manholes during April 6 and 7, 1982 survey.

1. Empty septic tanks and clean or replace drainfield so that overflows do not occur.

2. Continue to monitor system by local health authorities to assure that contamination does not occur.
