Publication No. 86-e28

STATE OF WASHINGTON
DEPARTMENT OF ECOLOGY
7272 Cleanwater Lane, LU-11 • Olympia, Washington 98504-6811 • (206) 753-2353

MEMORANDUM
November 18, 1986

Subject: Blaine Industrial Sector Wastewater Discharge to Drayton Harbor

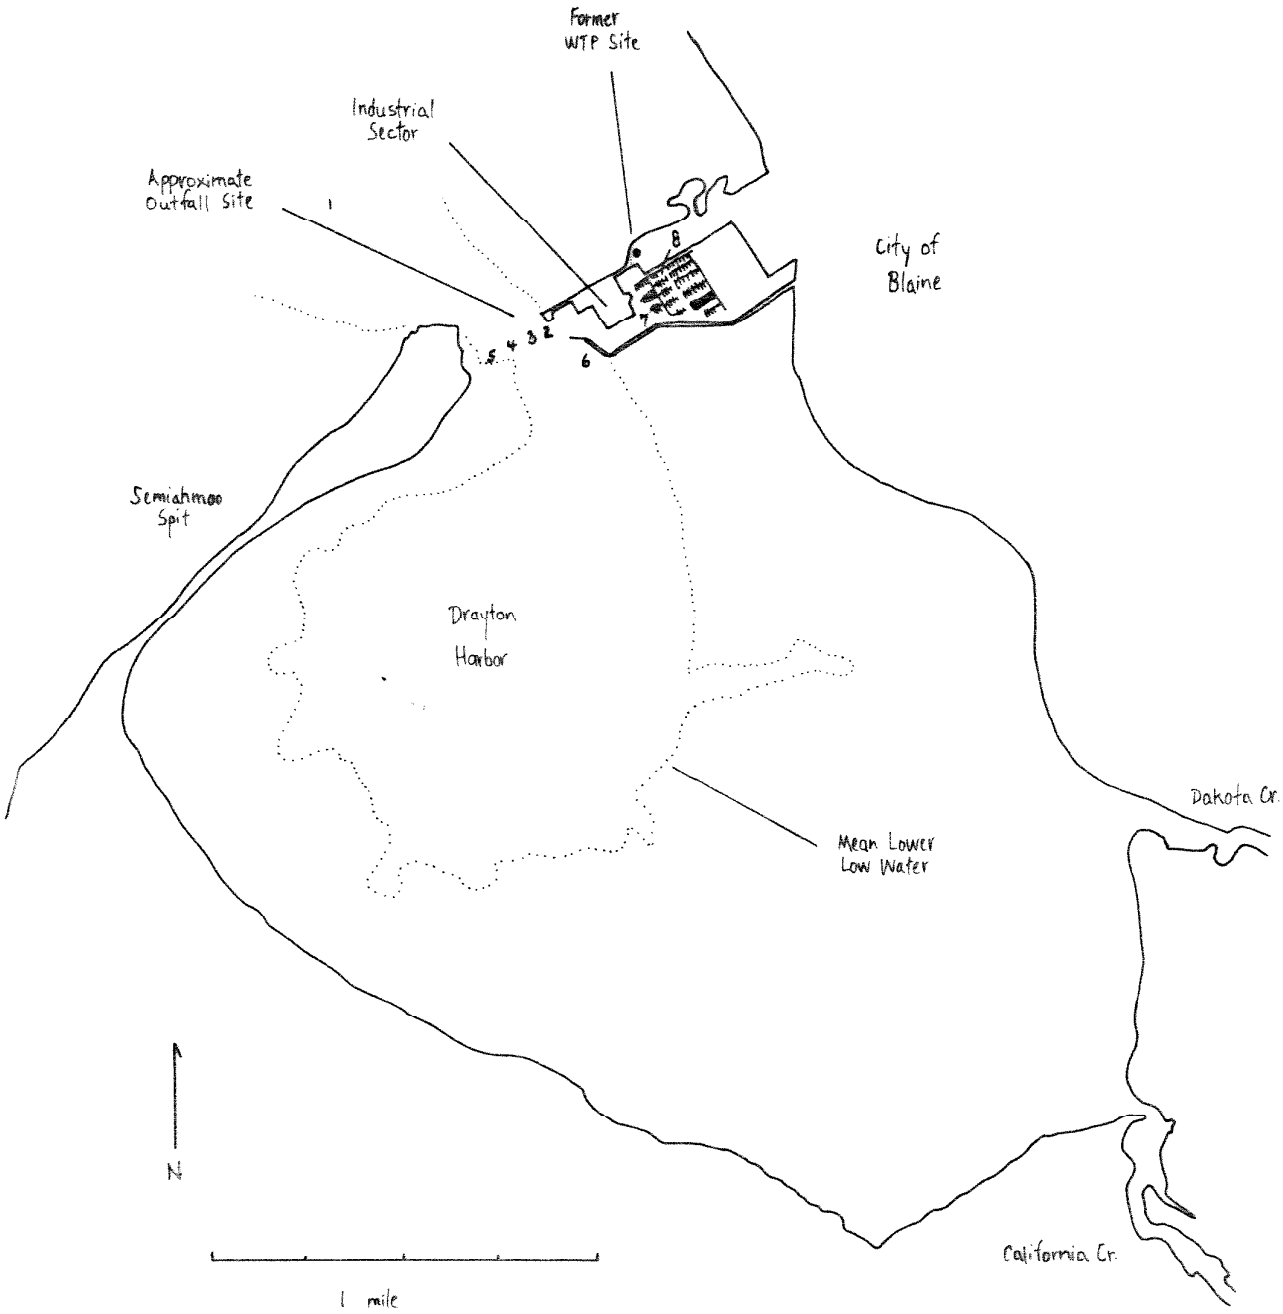
Figure 1. Map of Drayton Harbor showing location of industrial sector and approximate site of illegal discharge. Numerals represent receiving water sampling sites during the reconnaissance survey.

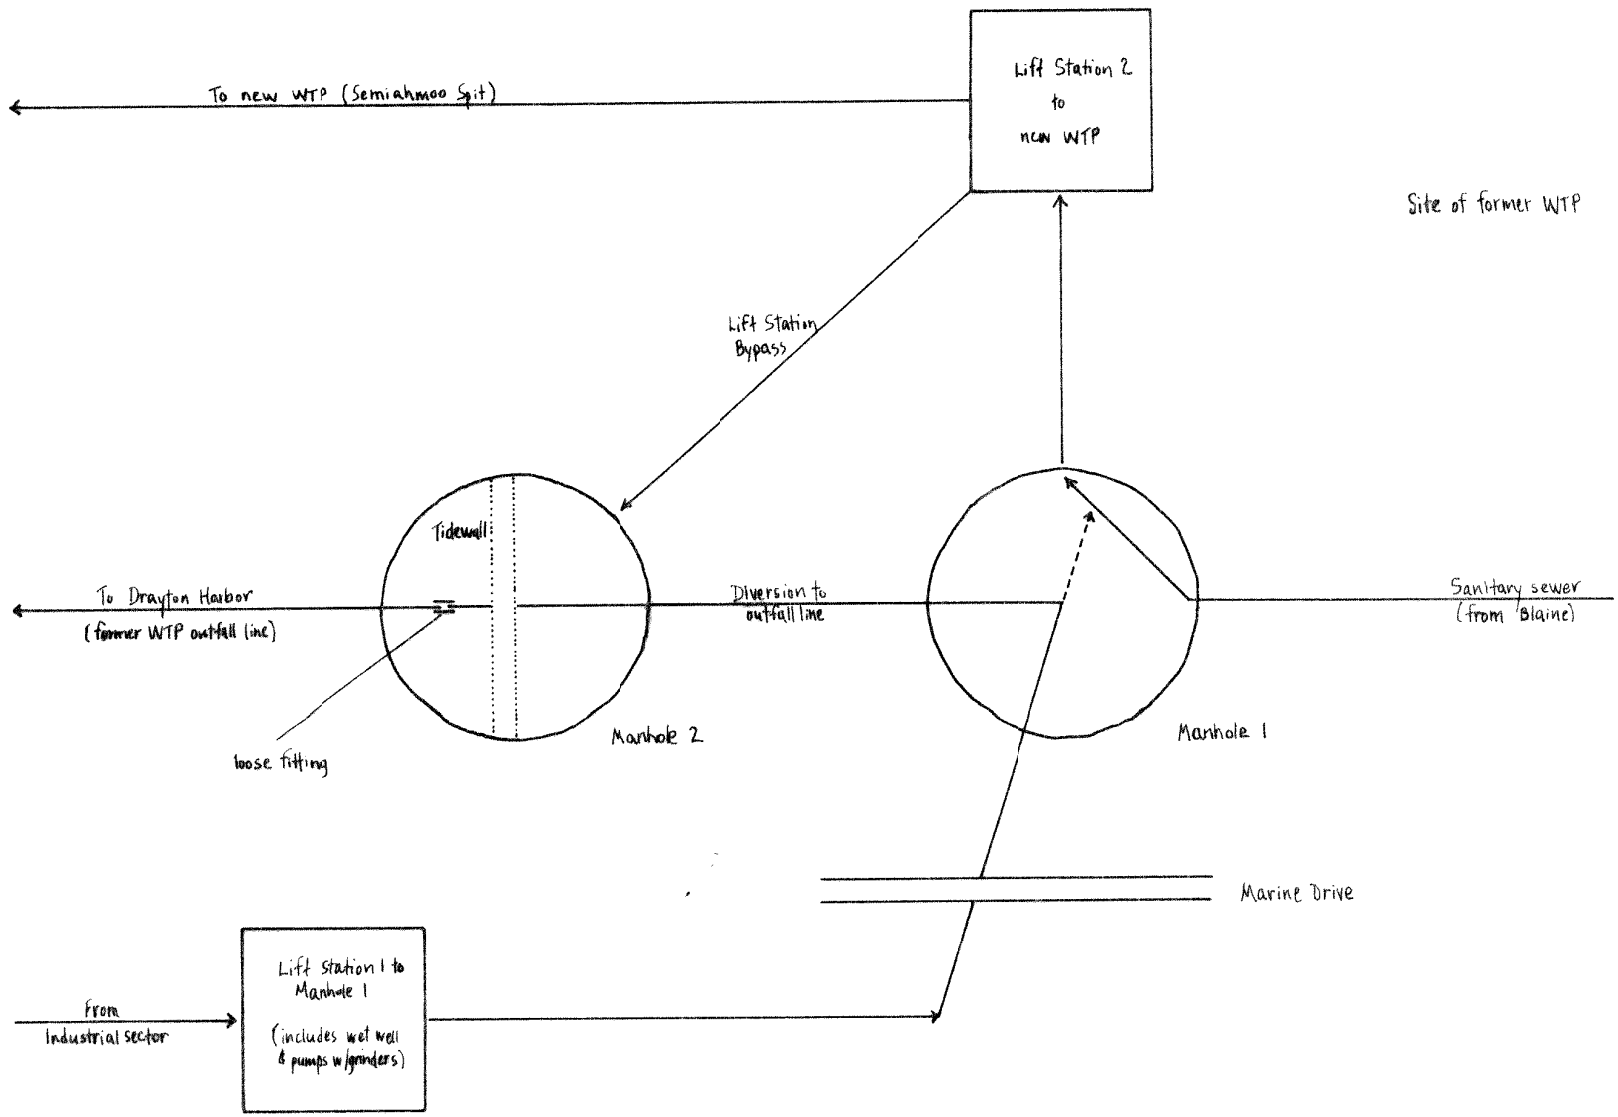
Wastewater from the Blaine industrial sector collects in a wet well near the old municipal WTP site (Figure 1). Upon filling, the contents of the well are ground and pumped to a manhole across the road (Figure 2). Originally, the wastewater joined the sanitary sewer at this point. However, after overloading the new WTP, the wastewater was diverted to a second manhole nearby where it flowed into an old outfall line. As a result, untreated wastes from the industrial sector are discharged directly to the mouth of Drayton Harbor.

Visual inspection of Manhole 2 during the reconnaissance survey showed that the diversion line from Manhole 1 led to the old WTP outfall line (Figure 2). During wet-well pump cycles at Lift Station 1, industrial wastewater backsurged into Manhole 2 from a loose fitting in the outfall line. A three-foot tidewall prevented the backsurge from overflowing into the sanitary sewer via the Lift Station 2 bypass. Upon completion of each pump cycle, the backsurged wastewater would slowly drain back into the old outfall line, suggesting that the line was only partially blocked in June.

Visual inspection of Manhole 2 during a low tide in August showed the backsurge completely overflowing the tidewall during pump cycles. The overflow drained into the sanitary sewer through both the Lift Station 2 bypass and the diversion line conduit (Figure 2); thus the overflow was ultimately treated at the WTP. Rate of tidewall overflow was estimated to be 100 gallons per 10-second cycle, with two minutes separating cycles. Between pump cycles, the level of backsurged wastewater did not subside, indicating that the outfall line was completely blocked. City officials noted that the age and condition of the old outfall are such that the line periodically fills with sediment. In the past, the city has tried to clear the blockage with high-pressure water blasts, but these attempts have met with limited success.

Figure 2. Flow diagram showing diversion of industrial sector wastewater to Drayton Harbor (dashed line indicates original flow path of industrial waste stream). For reference, manholes are located 20 feet apart, while lift stations are about 200 feet apart.

The strength of Blaine's industrial sector effluent and the high quality of the Drayton Harbor receiving environment necessitate prevention of future illegal discharges. Simple screening and oil separation should provide adequate pretreatment to prevent municipal WTP overloading. Pretreatment costs may be partially offset by shipping recovered wastes to a reduction facility for processing into meal, oil, and fertilizer.
