DST AY-102 Riser 83 Weekly Inspection Summary (August 5, 2013)

Monitor and characterize any changes identified near the AY-102 annulus Riser 83 waste accumulation site.

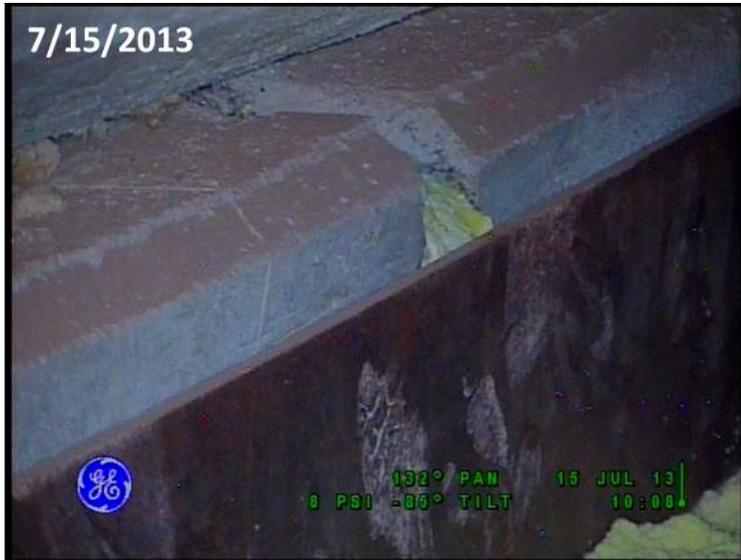
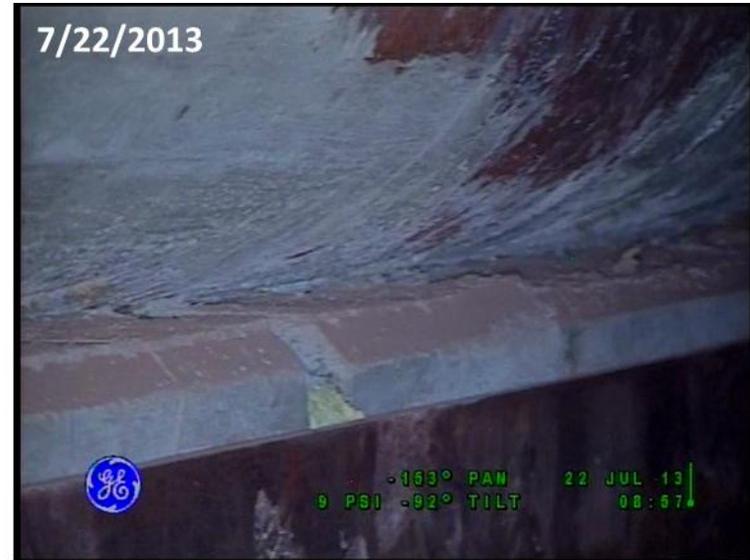
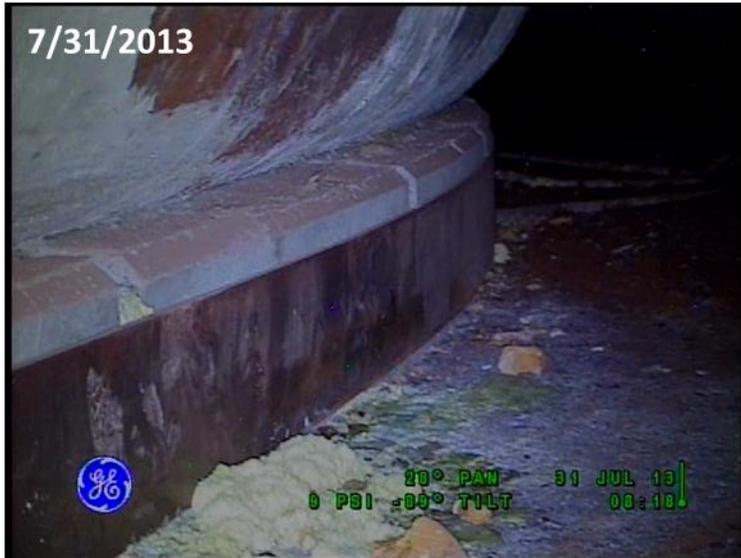
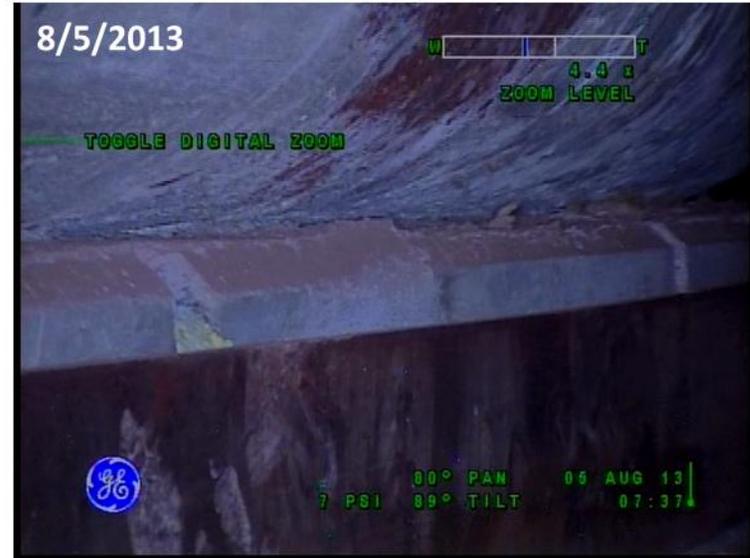
Refractory Slot: No change in appearance noted when compared to previous inspections.

There was no detectable appearance change in the refractory slot.

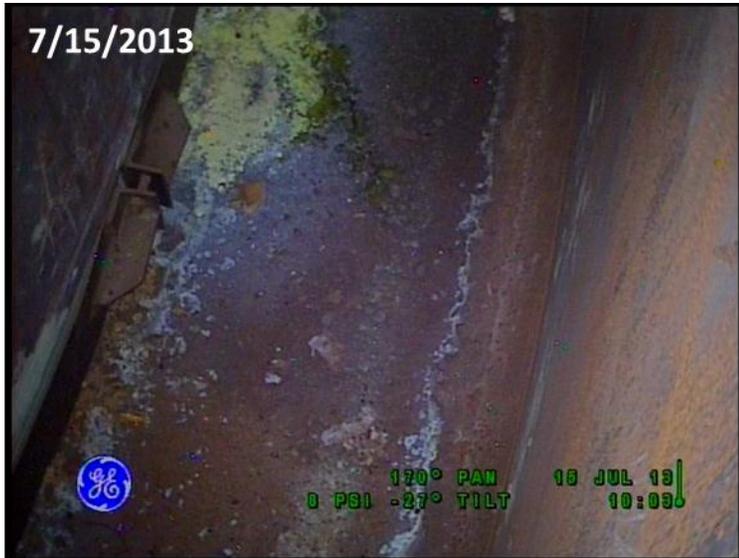
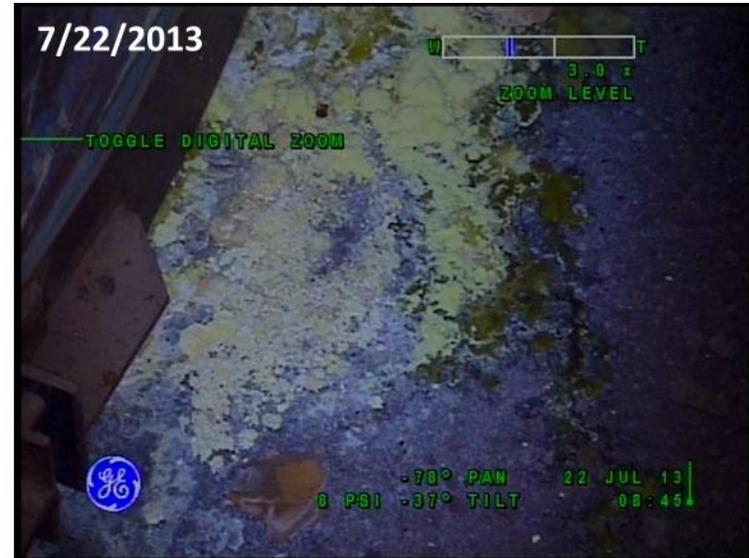
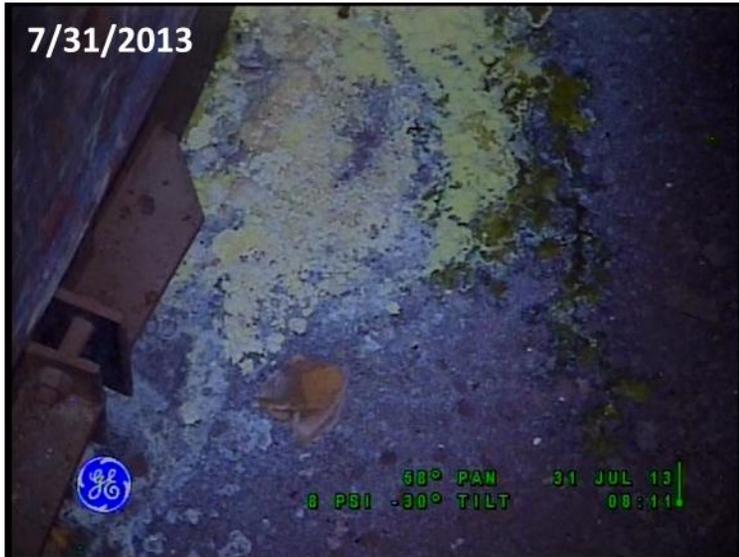
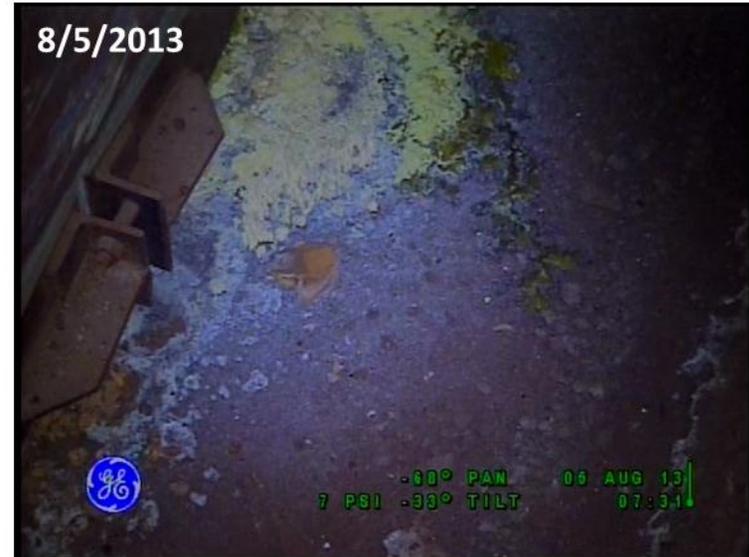
Annulus Floor: No change in appearance noted when compared to previous inspections.

- The waste continues to show signs of drying out.
- No additional waste material was identified resulting in volume increase.

There was no detectable appearance change on the annulus floor. Material continues to show signs of drying out.

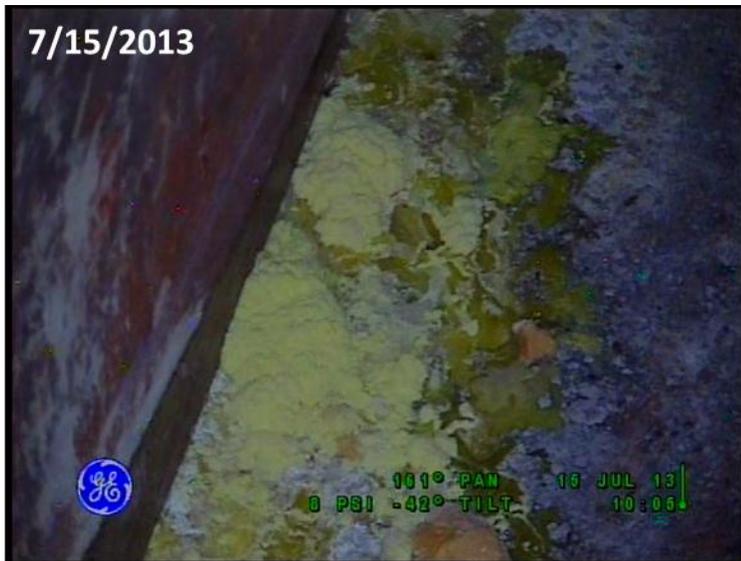
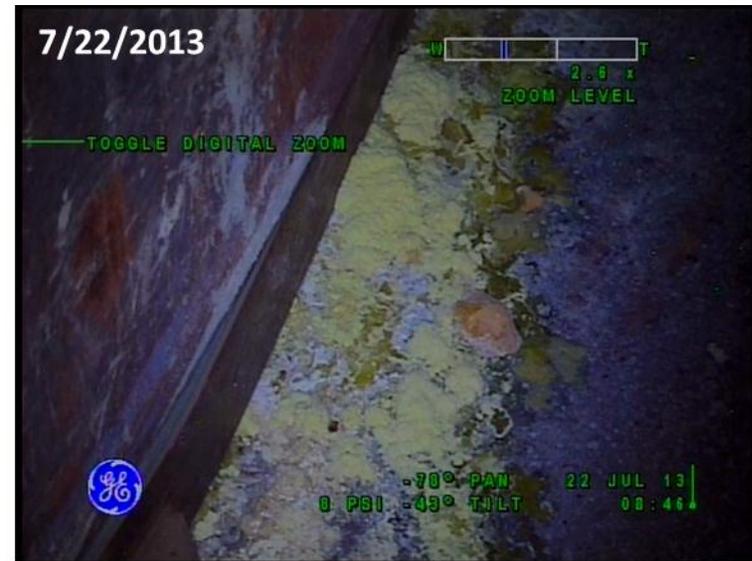
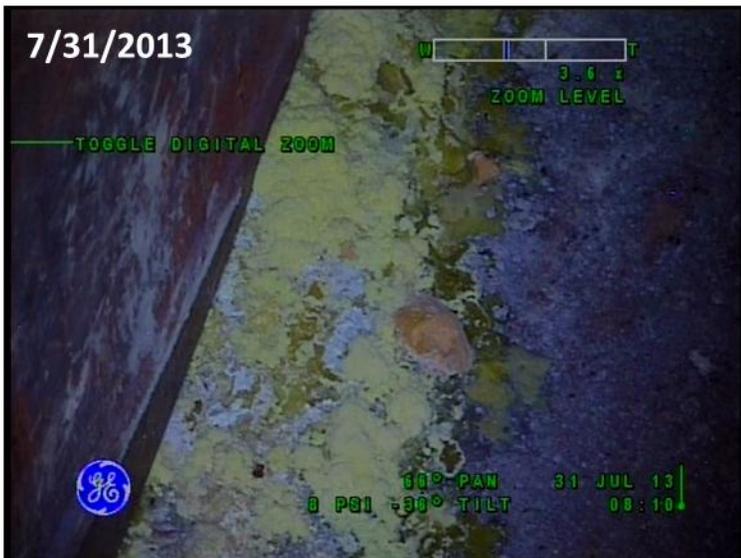
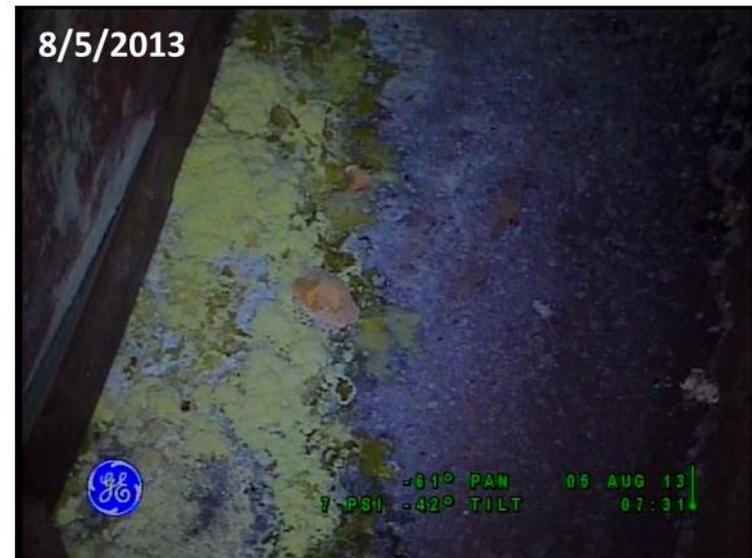
There was no detectable appearance change on the annulus floor. Material continues to show signs of drying out.

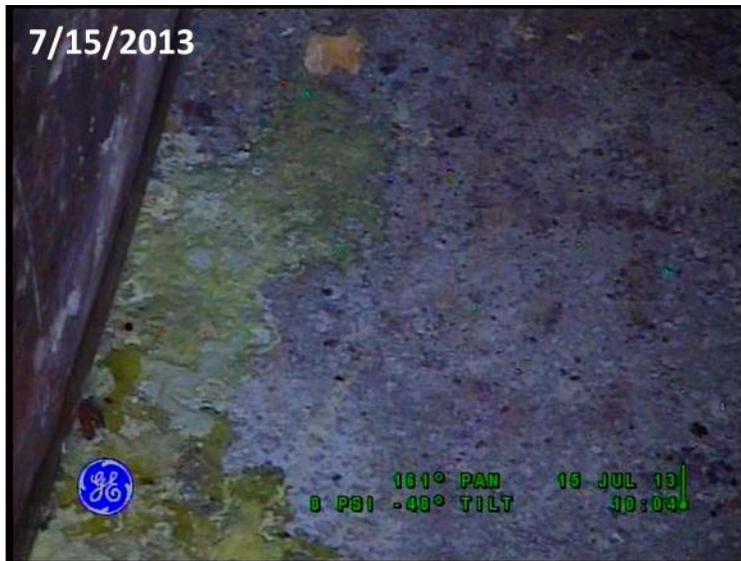
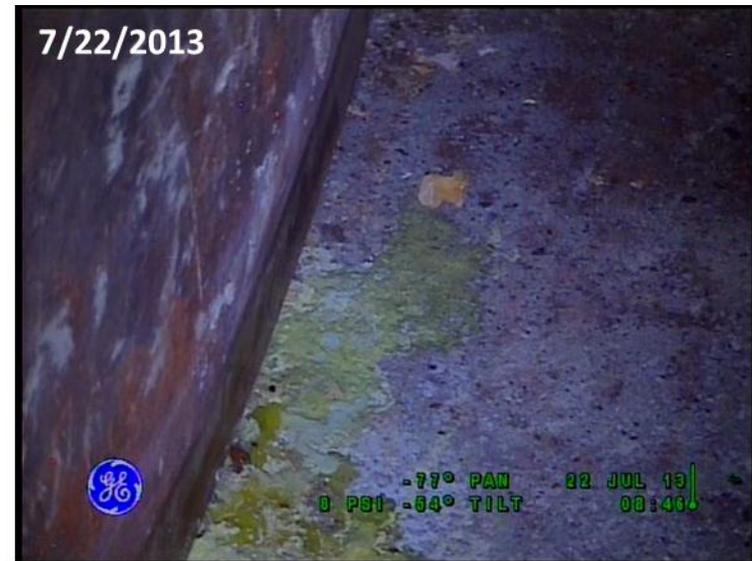
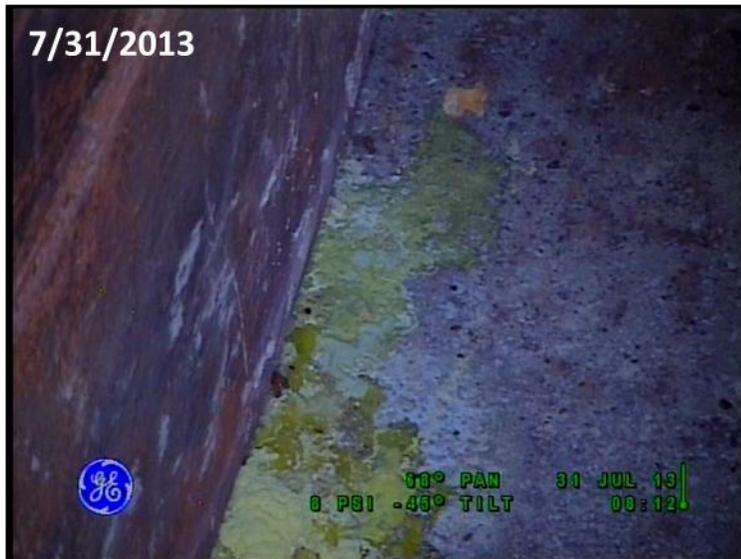
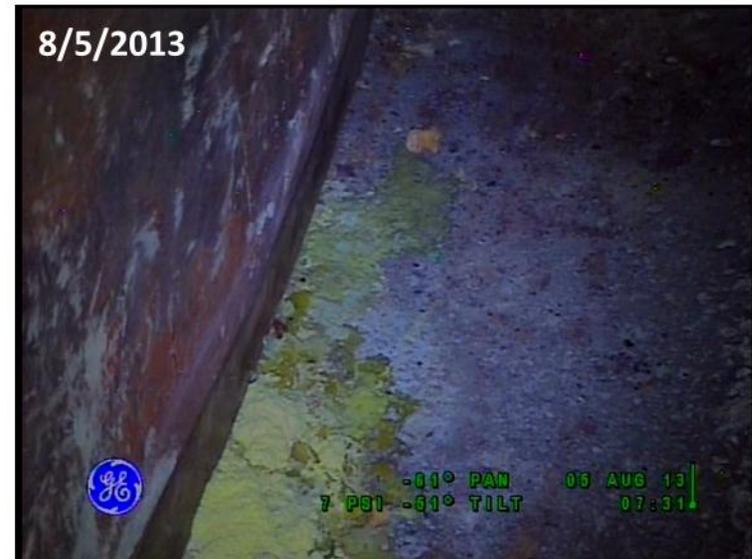
There was no detectable appearance change on the annulus floor. Material continues to show signs of drying out.
