Incident Report: Davy Crockett Emergency Response

Update as of July 14, 2011

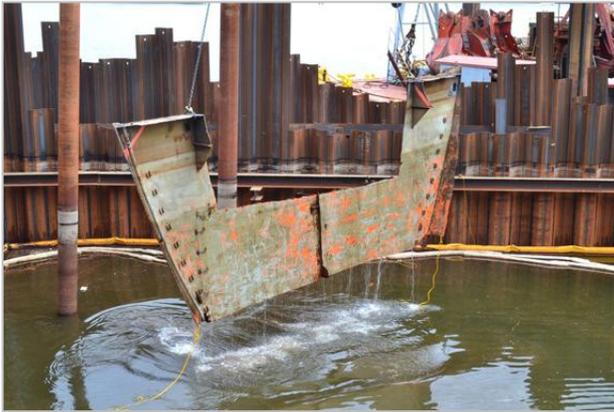
The forward cargo hold #1 bulkhead is lifted from the Davy Crockett. (7/14/11)

Divers removed the forward cargo hold #1 bulkhead on Thursday, July 14, 2011 (see photo gallery).
