## Incident Report: Davy Crockett Emergency Response

Update as of August 12, 2011

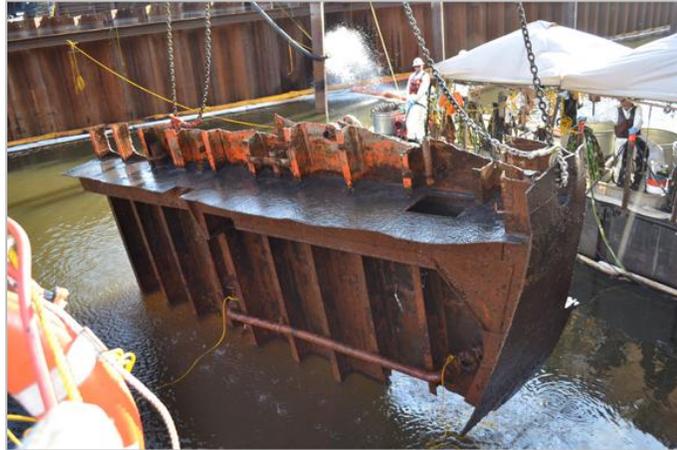
*Large section of the bow cut and removed on Aug. 12, 2011.*

Dive crews continued work on the remaining sections of the bow, removing the port side aft deep tank bulkhead at frame #39 and prepping the starboard side for removal.
