## Incident Report: Davy Crockett Emergency Response

Update as of August 22, 2011

### OPERATIONS UPDATE – August 22, 2011

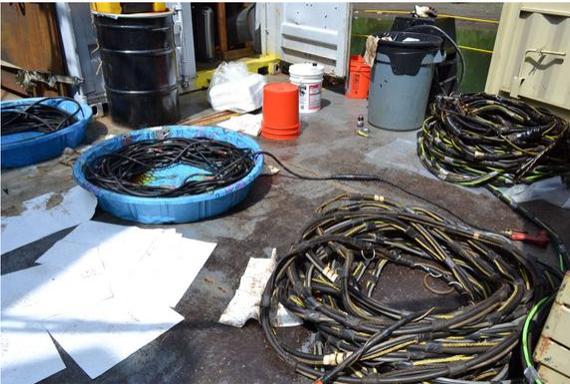
*Underwater cutting equipment and dive gear in decontamination station. (8/22/11)*

Due to low river levels, the Davy Crockett worksite command and dive support barges are being moved from the shore side of the cofferdam to the channel side. As part of the site changes and as the project nears the end of the vessel removal effort, top-side crews conducted dive gear maintenance and demobilized underwater cutting equipment on Monday, August 22 (see photo gallery).

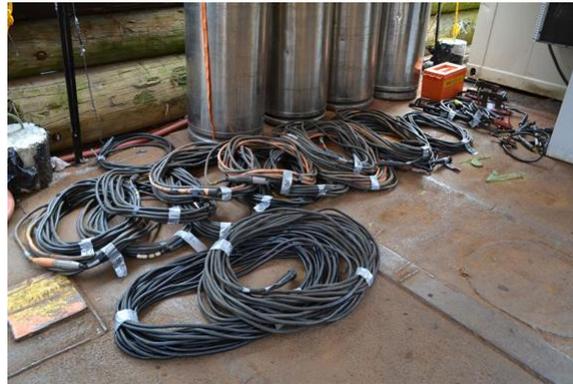
*Underwater cutting equipment organized for demobilization after being decontaminated. (8/22/11)*
