U.S. Department of
Homeland Security
**United States
Coast Guard**

Incident Report: Davy Crockett Emergency Response

Update as of August 25, 2011

OPERATIONS UPDATE – August 25, 2011

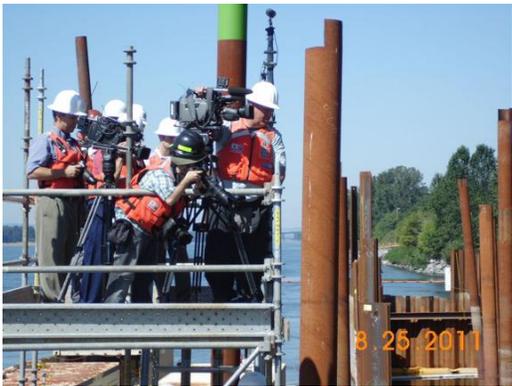
Reporters and news photographers document the last section of the Davy Crockett being removed from the Columbia River. (8/25/11)

Crews lifted and cleaned the final section of the Davy Crockett from the river bottom inside the cofferdam on Thursday, Aug. 25, 2011, completing the vessel deconstruction phase of the project (see photo gallery). The pollution threat posed by the Davy Crockett - which sparked the nearly seven-month operation - is now eliminated.

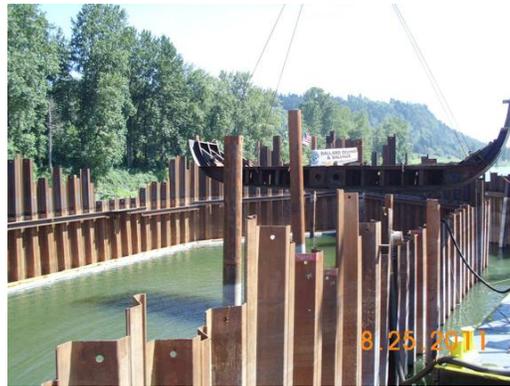
The last section of the Davy Crockett is lifted over the cofferdam to the cleaning barge. (8/25/11)
