KapStone Container Corporation

NW Commingled Workshop

occ quality issues at the
Longview, WA mill

Problems Caused by Non-Paper Contamination

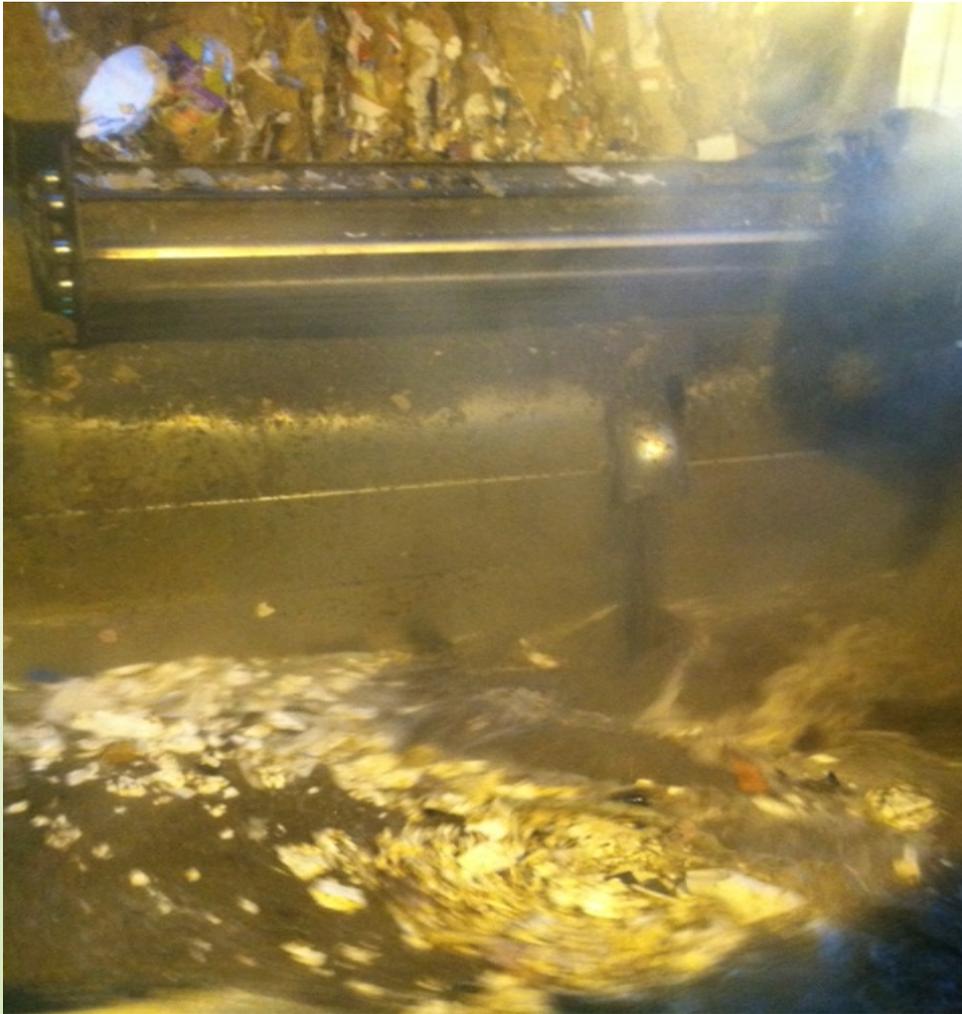
This is the top of the pulper where they conveyor drops bales.

Notice the swirling styrofoam.

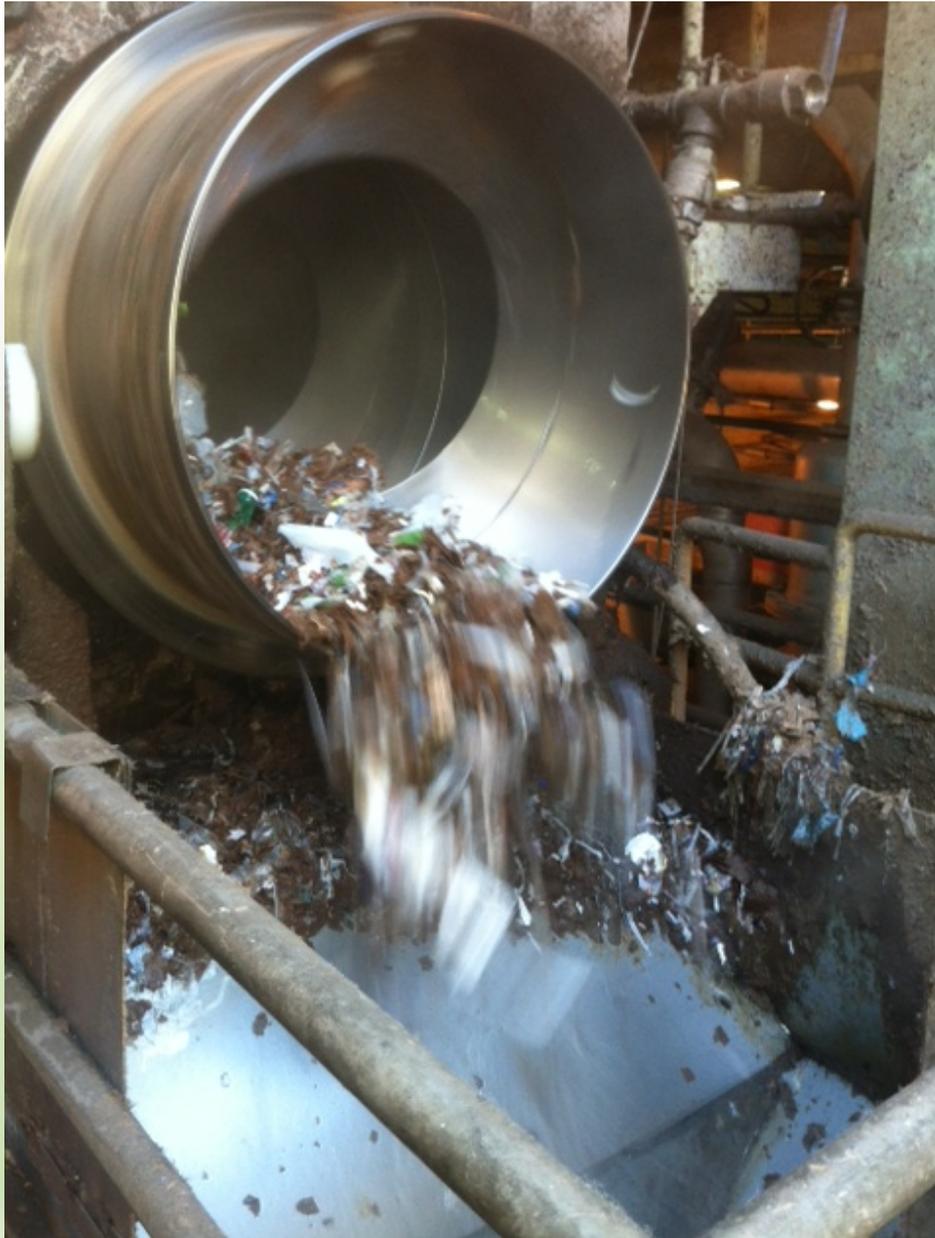
Steady stream
of rejects
coming from the
pulper trash
remover.

All of this
material must be
landfilled.

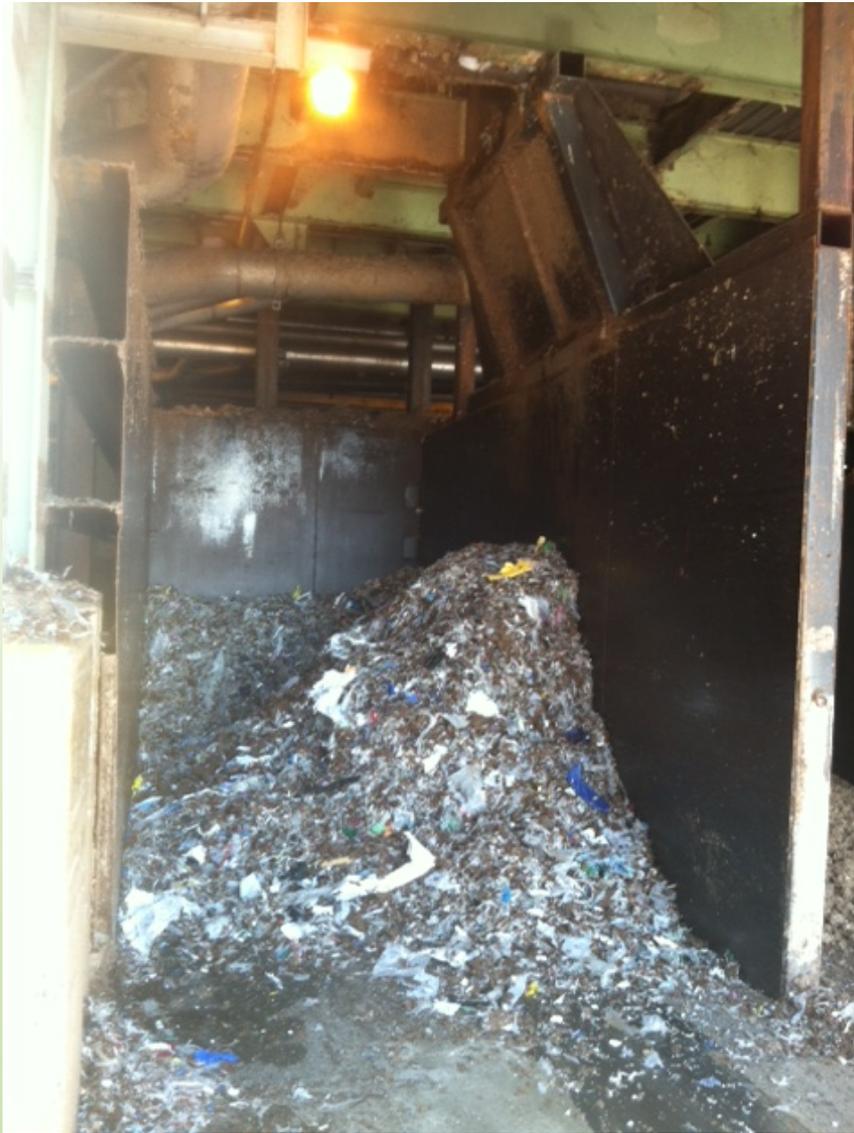
After going through a press to remove water, rejects fall into this bunker.

This material is loaded into a garbage truck for removal.

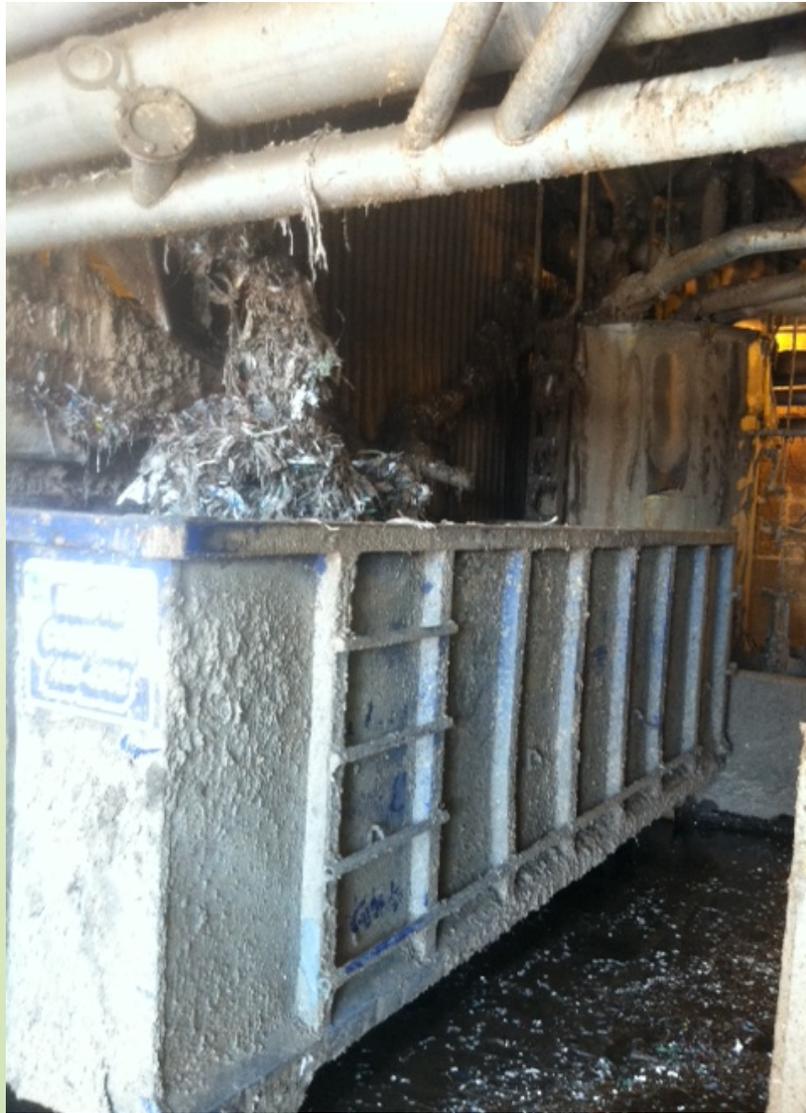
This is the rager tail in the pulper (a piece of rope hung in the pulper to collect bale wires). Because it is contaminated with plastic, we cannot recycle the metal.

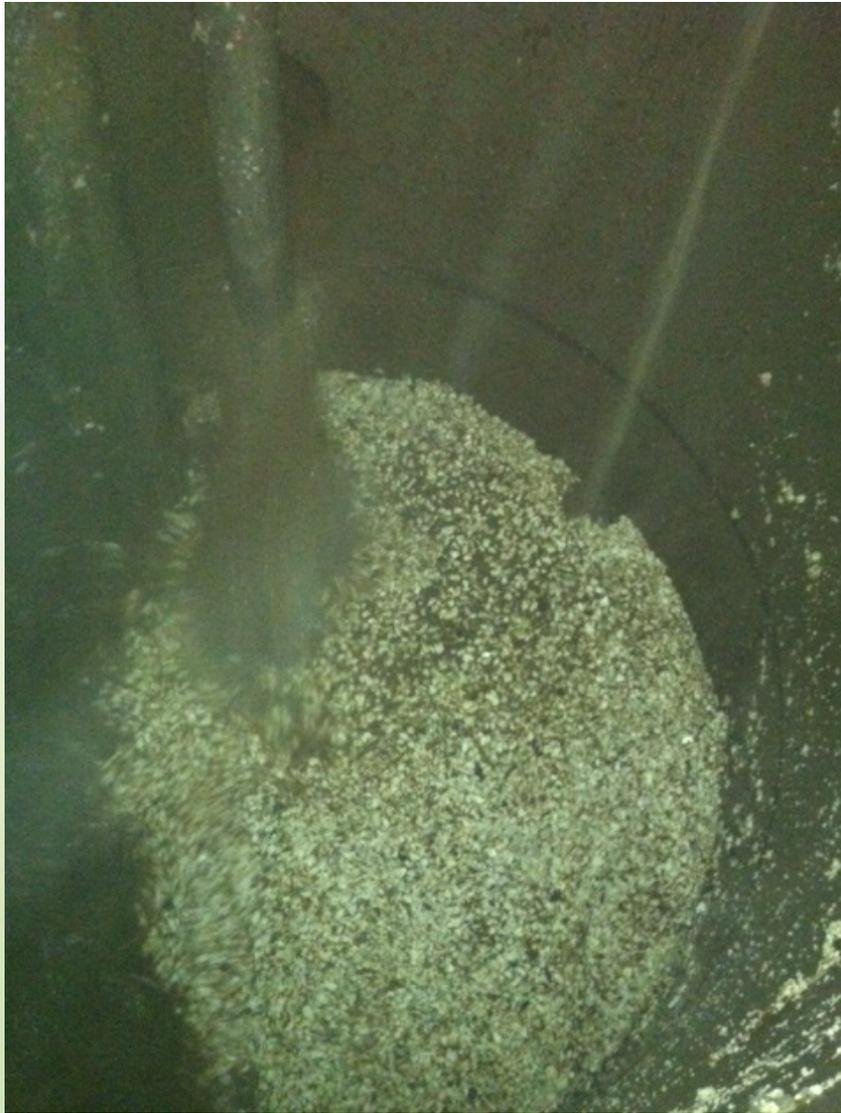
This is the feed tank to the final detrashing equipment. This tank fills with styrofoam so quickly that we are forced to have a vacuum truck come and remove the styrofoam.

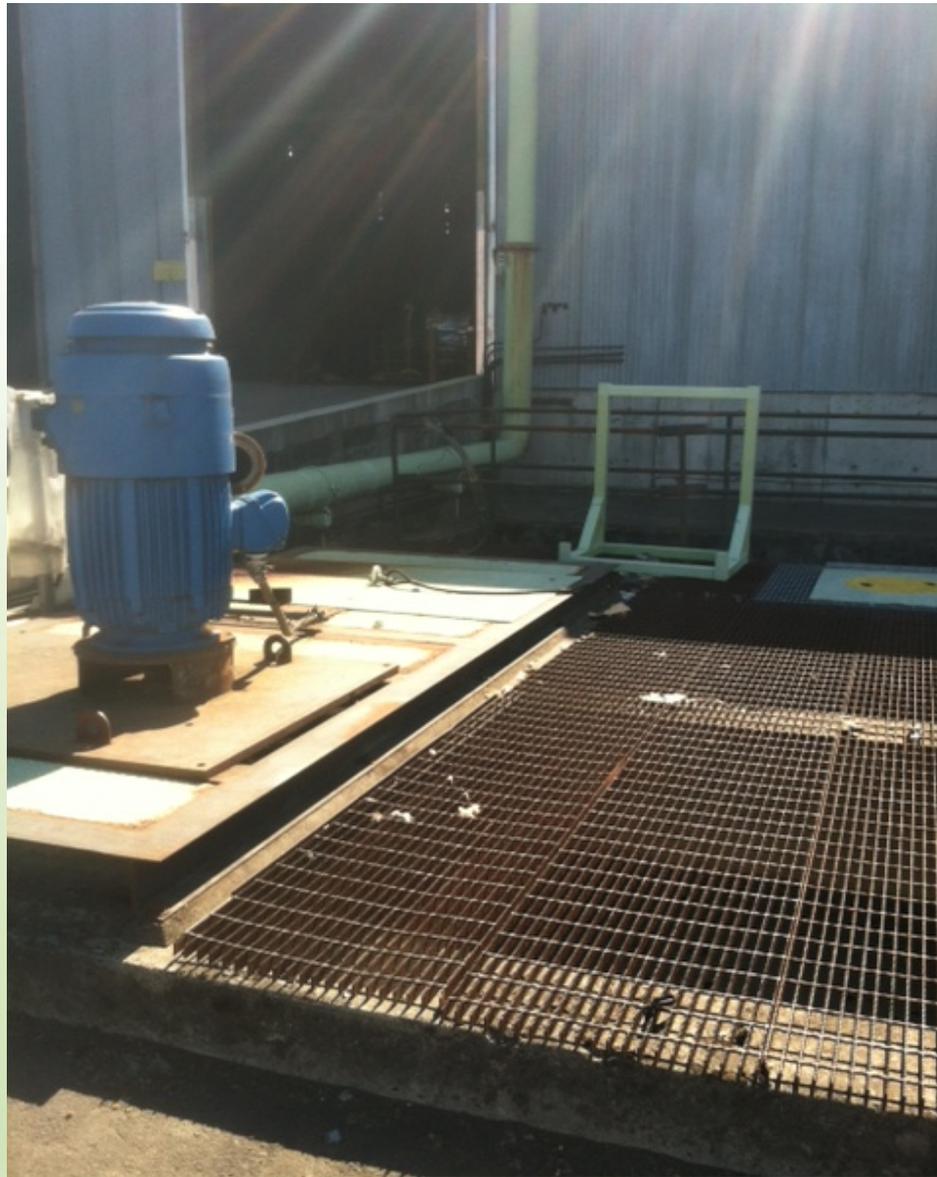
This is one of the sewer transfer stations that must have styrofoam removed by a vacuum truck.
