Georgetown Steam Plant

North Boeing Field

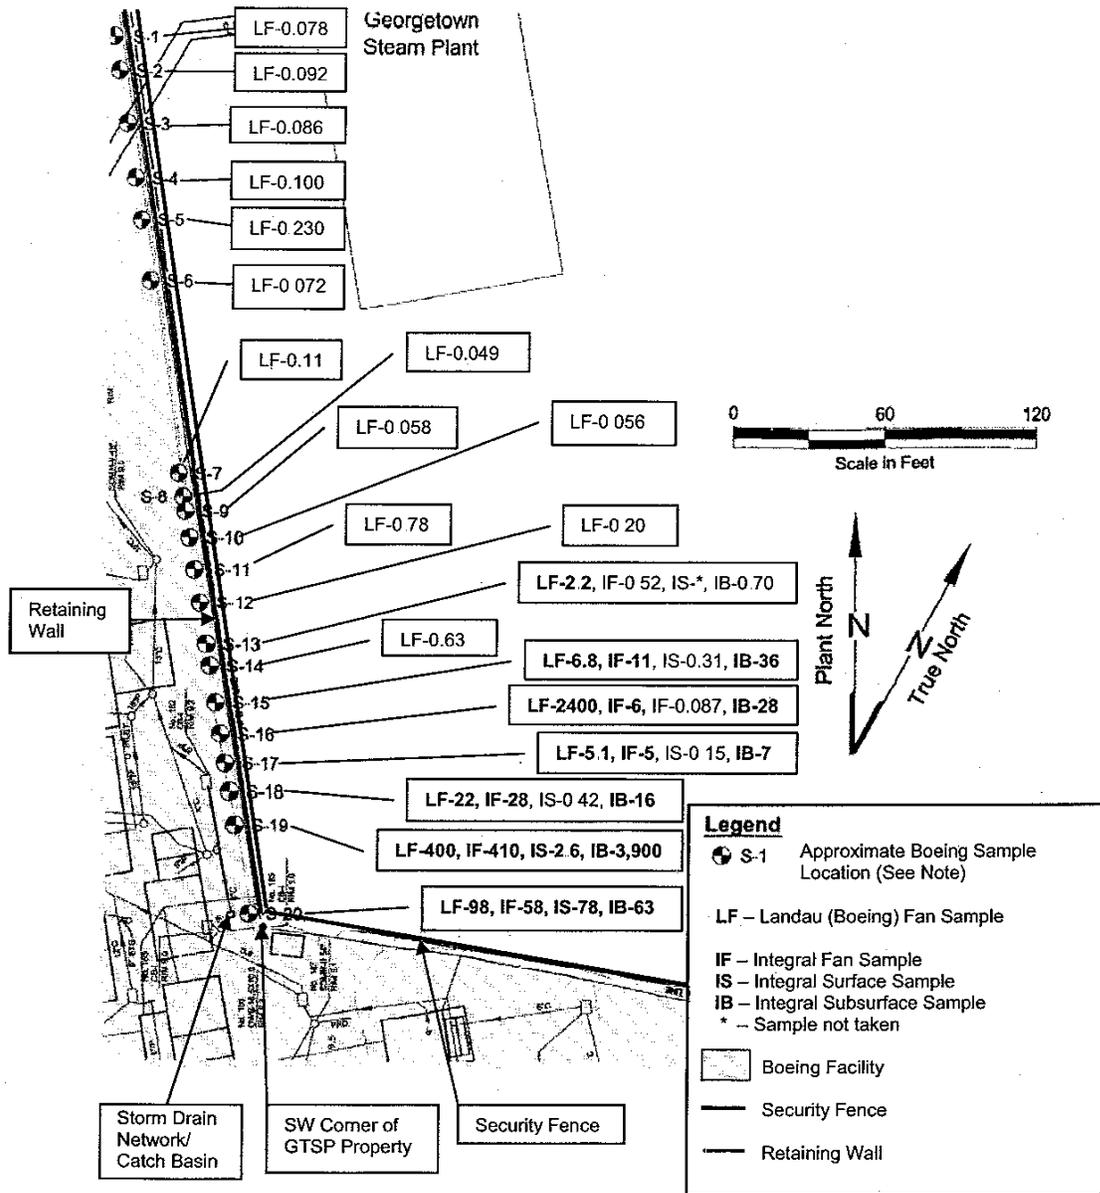
Figure 4. Soil Sampling at GTSP/NBF Fenceline (2005/2006)
Source: SCL 2006

Note:
Total PCBs concentrations are reported as mg/kg. Bold indicates total PCB concentration is greater than 1.0 mg/kg

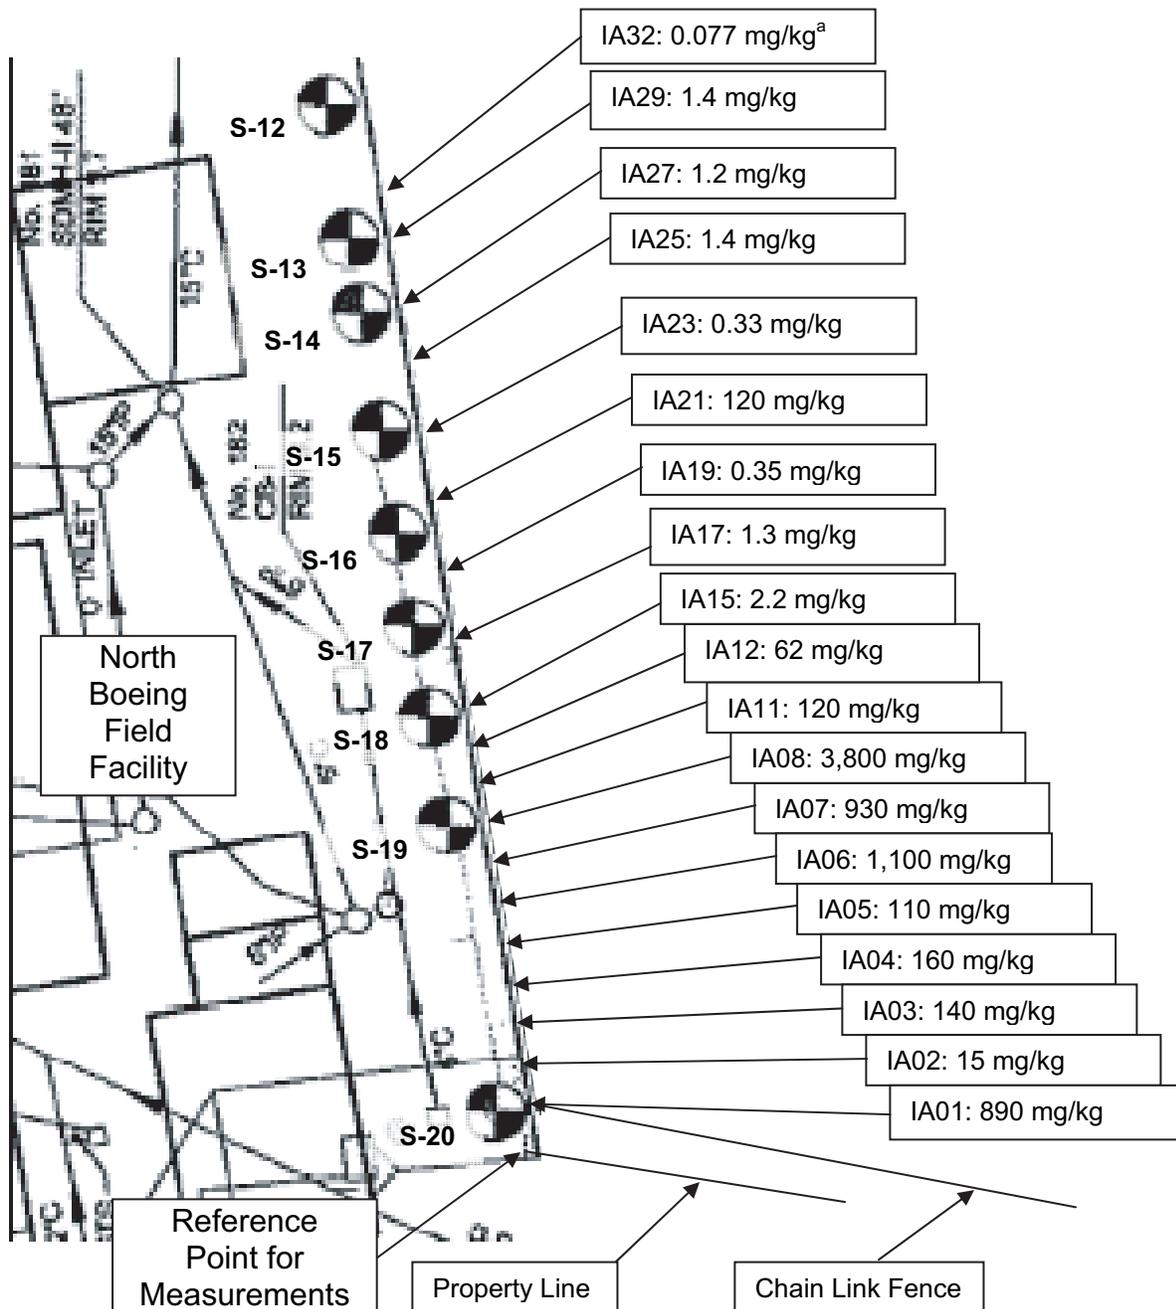
The PCB concentrations noted below are from samples collected at approximately 1.5 m intervals at the base of the interim action excavation. These results will be considered in developing the upcoming site-wide investigation plan. For reference, Sample Stations S-12 through S-20 indicate positions of previous soil sampling.

^aResult includes sum of Aroclors 1254 and 1260. For all other samples, only Aroclor 1254 was detected.

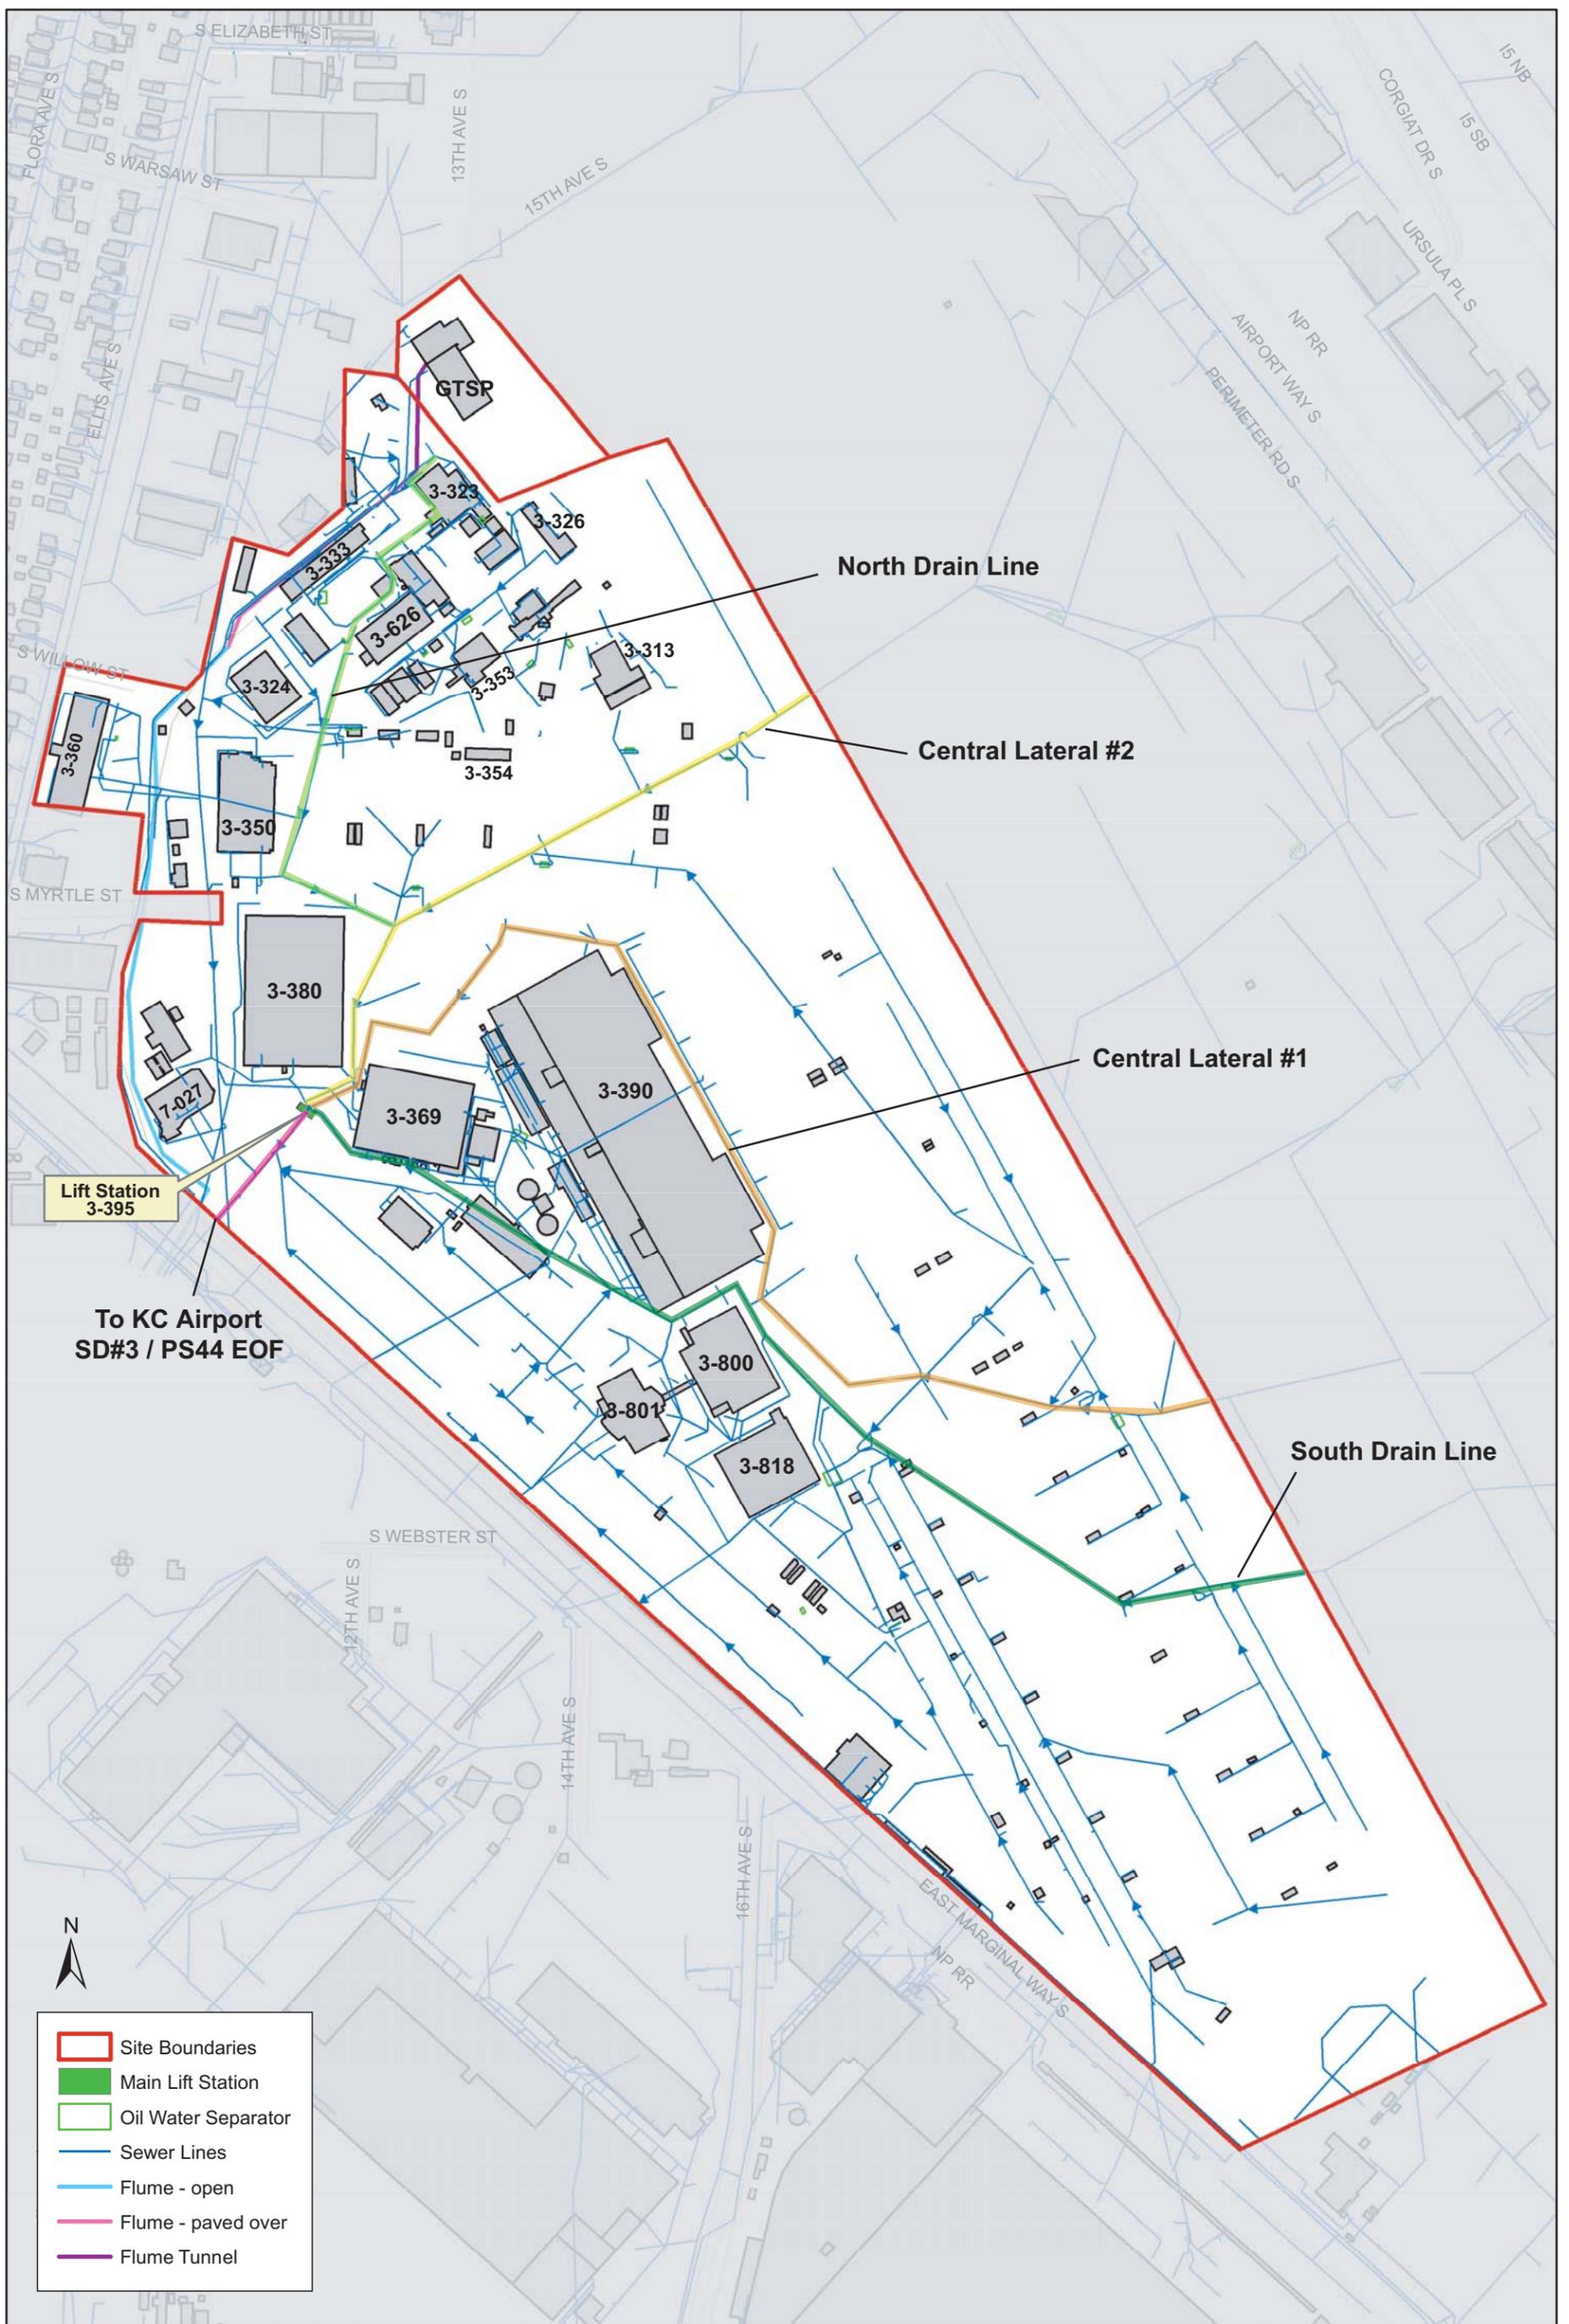
Figure 7. Storm Drain System at North Boeing Field

- ▭ Site Boundaries
- ▭ Main Lift Station
- Oil Water Separator
- Sewer Lines
- Flume - open
- Flume - paved over
- Flume Tunnel
