Subject: Comments on Proposed Rule for WRIA 17 Quilcene-Snow Water Resources Management Program

This comment regards the unnamed stream depicted on Map C, found on page 8 of proposed Chapter 173-517 WAC.

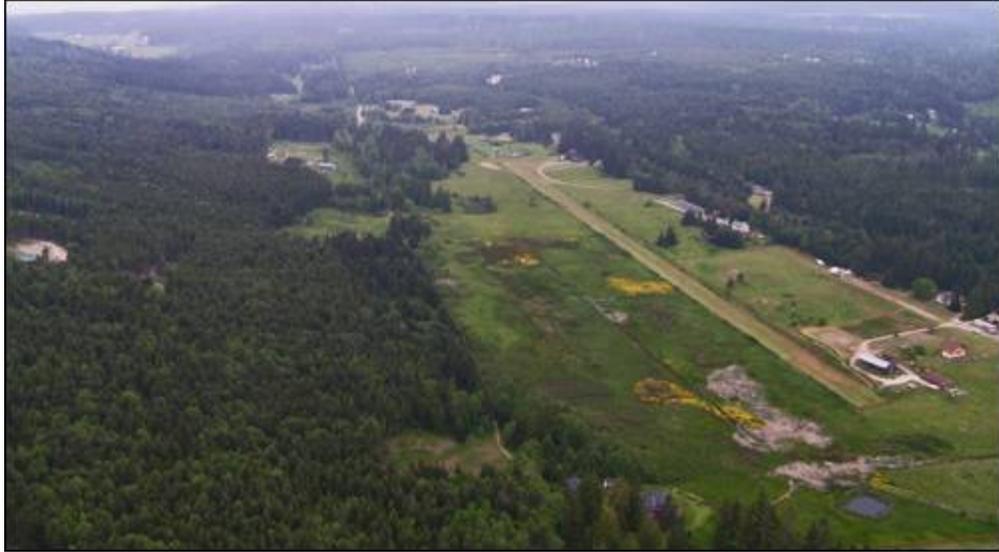
The first photo is an aerial photo taken from just north of the golf course, looking north. There is no channel north of the northernmost patch of scotch broom. In fact, most of this section of the unnamed stream is more accurately definable as a man-made drainage ditch system that was first put in place in support of the valley's agricultural activities. Soil types here are excellent for agricultural purposes, although some of the farming activities in the valley have not been continued to the present.

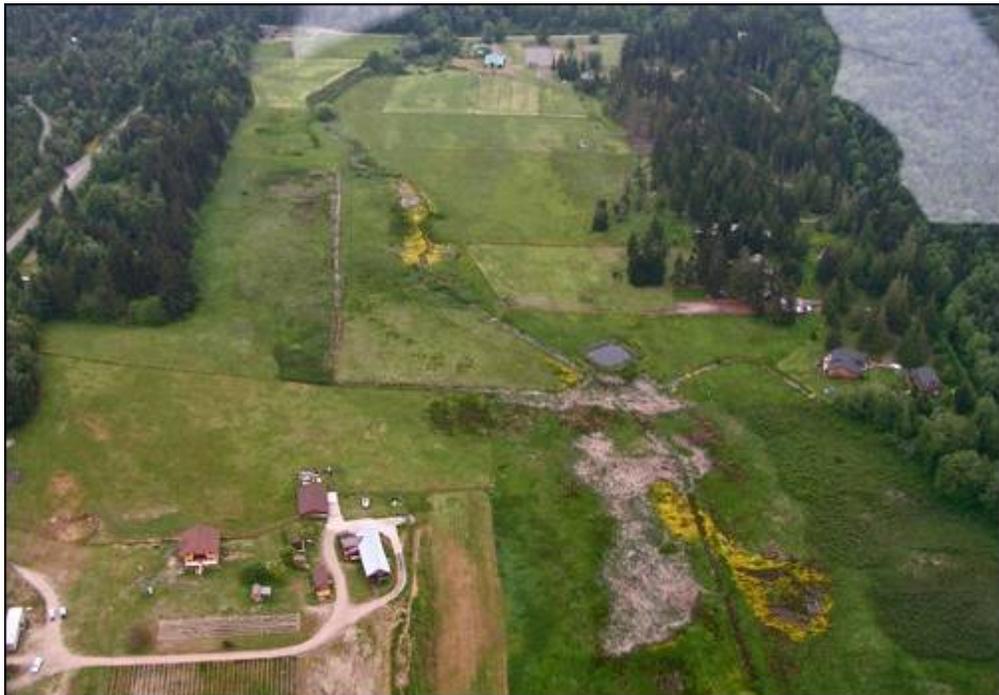
The next aerial view is looking to the south. Again you can see that the northern portion of the stream, now at the bottom of the photo, is a straight line, denoting that this is part of a drainage ditch system. The small pond near the center is roughly square, and is another man-made feature. Active agriculture is evident to the southern boundary line of this group of parcels.

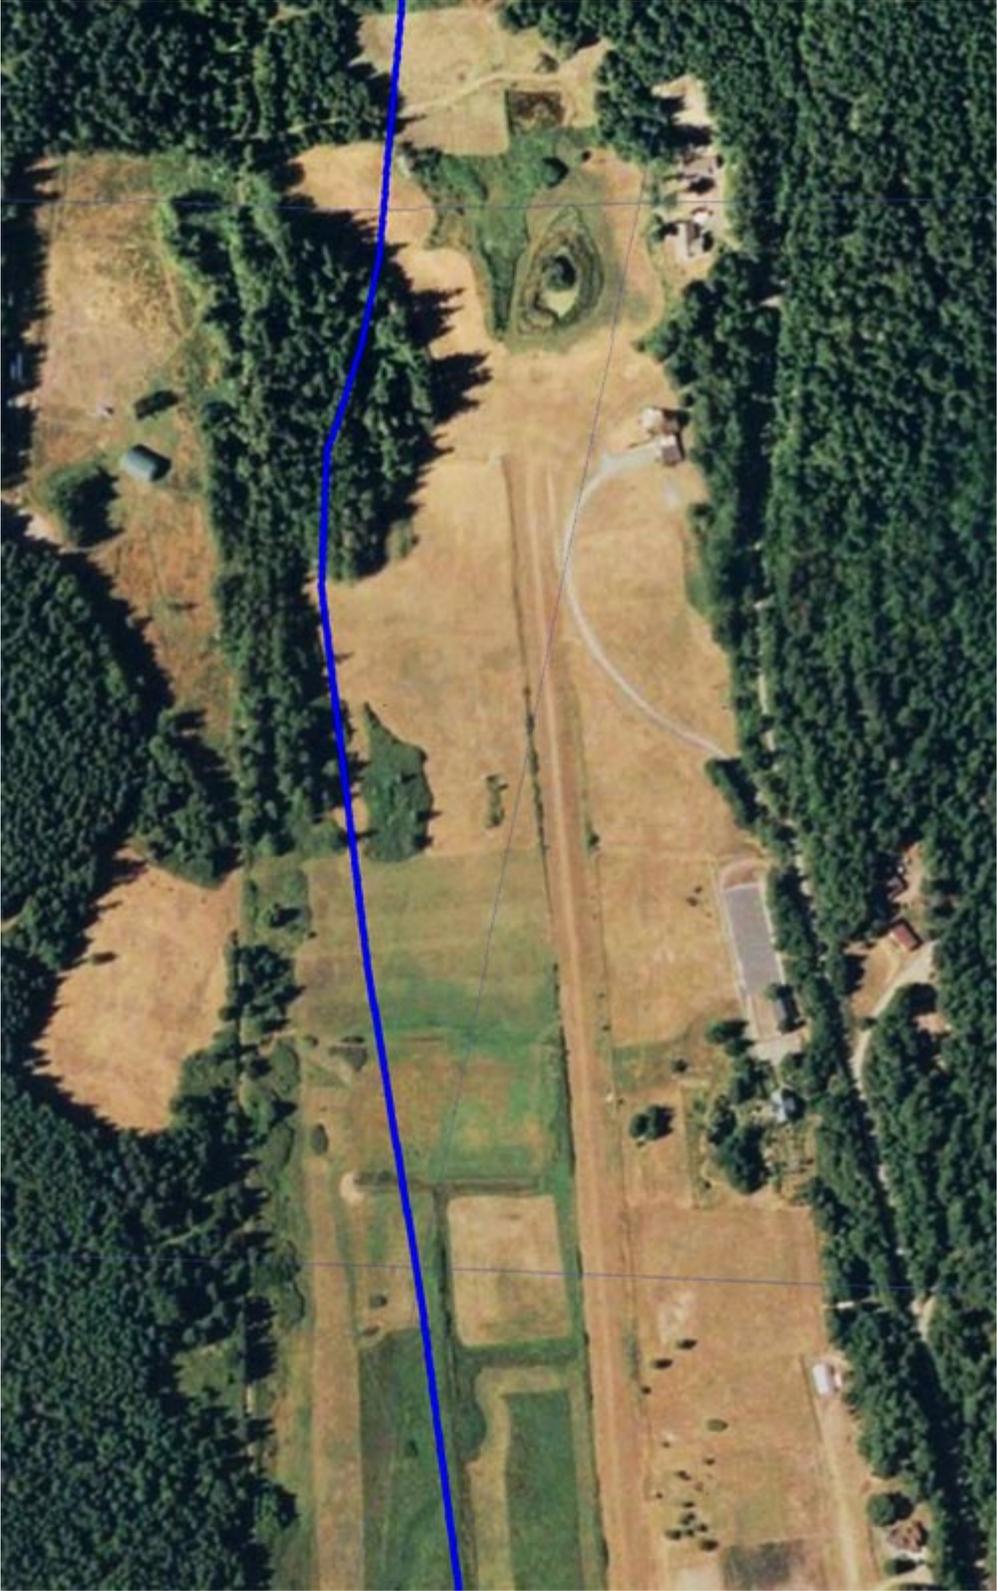
The following is cropped from ArcGIS imagery overlay with the Department of Ecology's overlay of the stream course. About one-third of the way up from the bottom of the image you can see where the drainage ditch system terminates with a rough "T" shape. There is no stream channel to the north of that point.

At the northern end of the runway, the topography slopes **down** to the north, while the stream is purported to be flowing to the south. The depicted stream course is to the west, and several feet higher than the intermittent depression wetland to the east of the blue line.

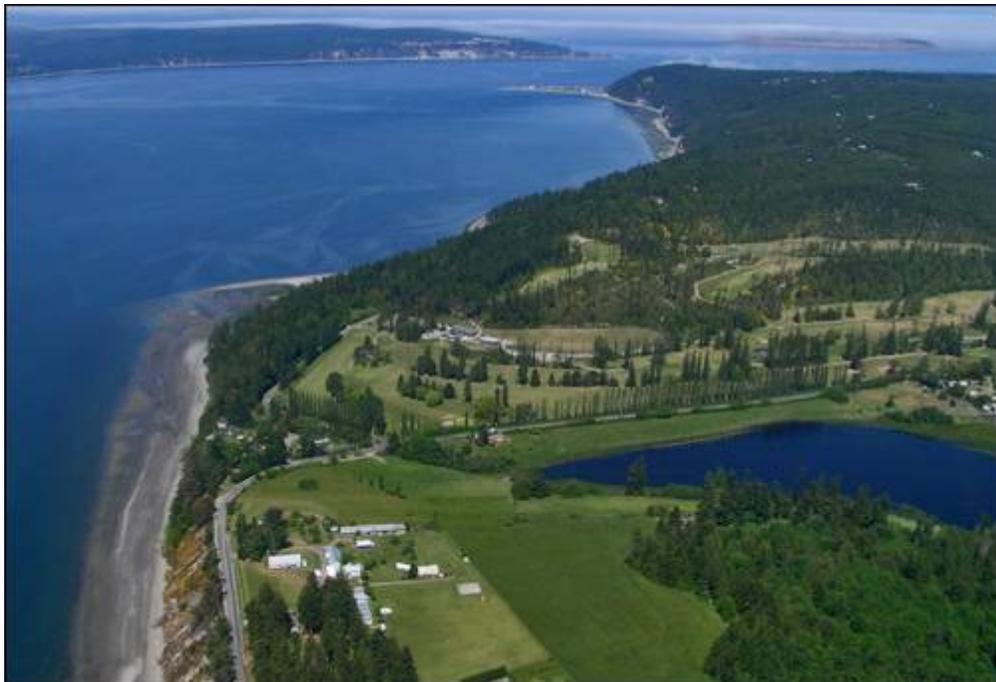
Now that we've taken a look at the disparity between the mapped head of the unnamed stream, let's take a look at its mouth. For orientation, the lower left of this aerial is located where Discovery road meets the high bluff at Discovery Bay, with the golf course seen at the center area of the photo. The unnamed stream flows during wet times from the pond seen in the lower right portion of the photo. At this size you cannot see the pasture fences that run across the pond, indicating that the pond does not always hold anywhere near the amount of water seen at this phase of our wet-dry cycle.

As can be readily seen, this shoreline is best categorized as high bluff waterfront. There is no stream channel or delta formation seen across the beach where the stream comes down over the bluff. This makes access to the stream problematic for fish.
